Allied Paper, Inc./Portage Creek/Kalamazoo River Superfund Site
King Highway Landfill Operable Unit 3
Sampling Plan for the Stressed Vegetation Area

April 27, 2012

Site Plan and Proposed Sampling
Locations

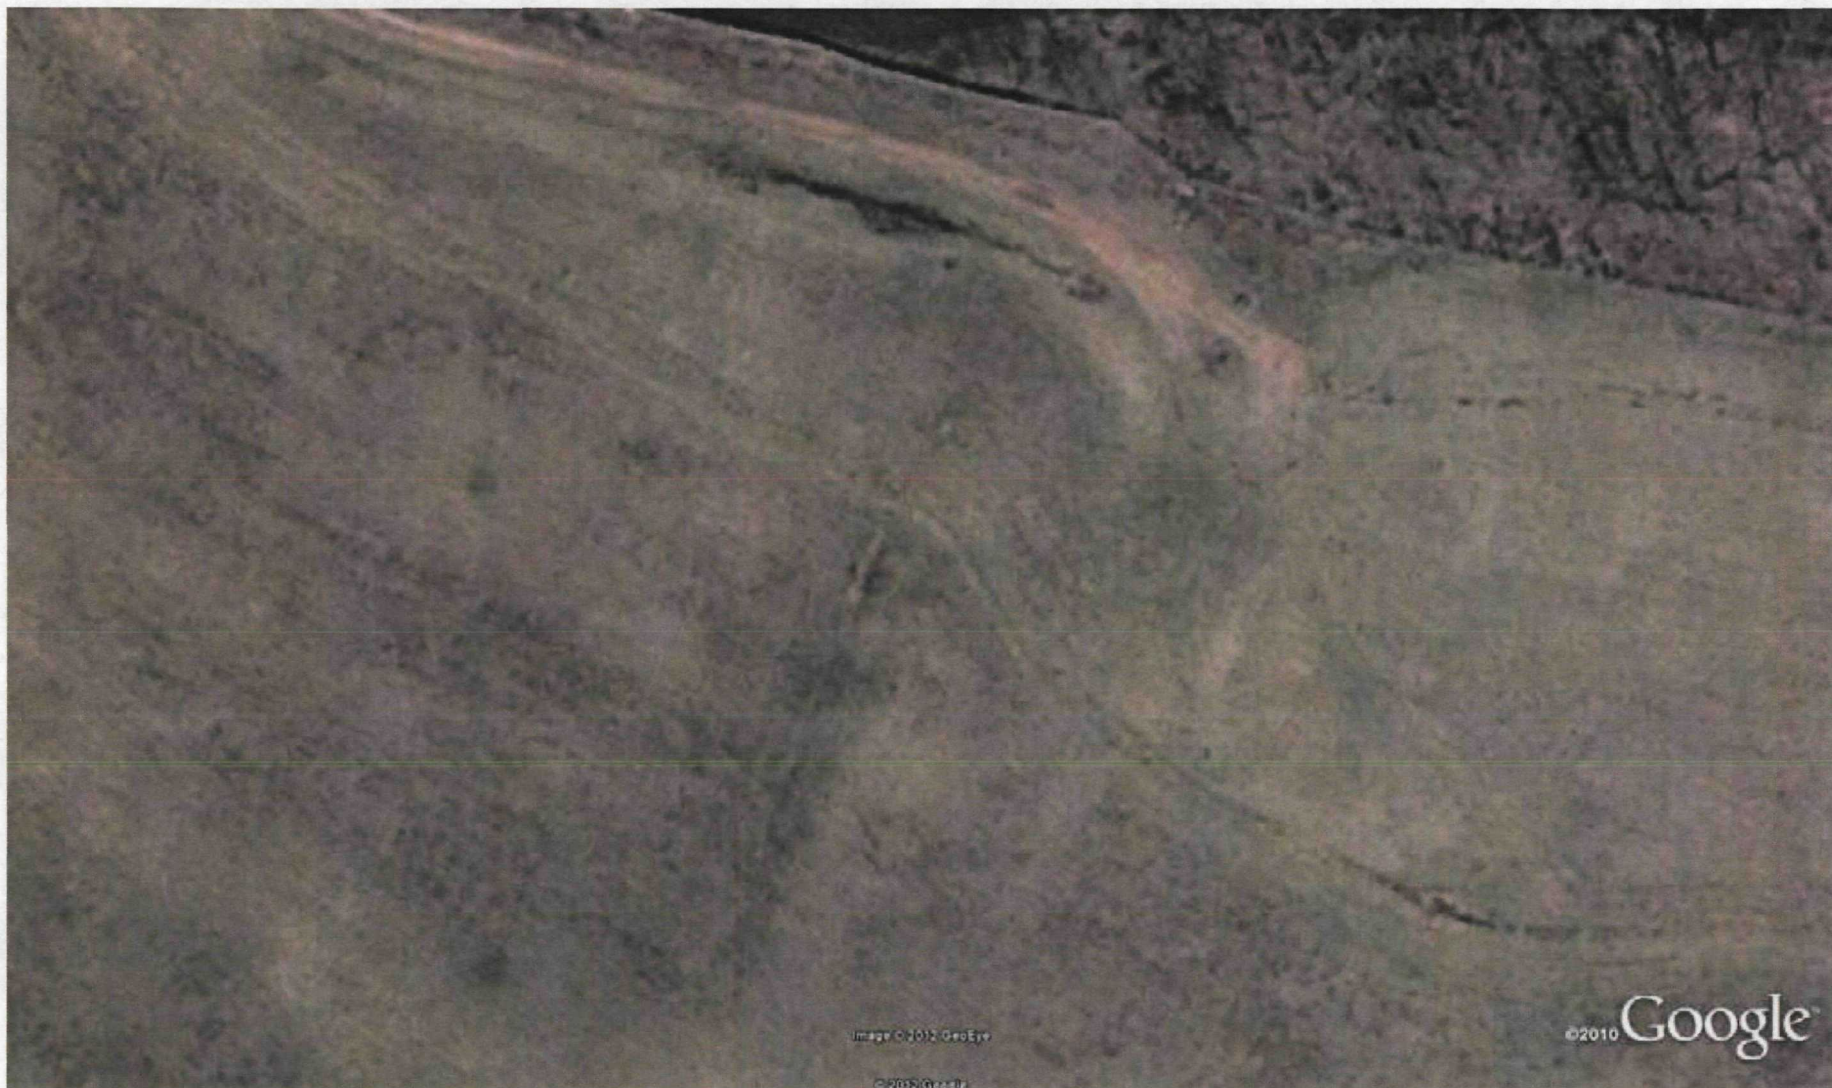
4/4/2010
Google Earth

Check out some aerial images from Google Earth and Bing. Looks like one from 2004 and another from 2006 (assumed year) had no spot. One from 2010 kind of appears to have the spot, and then the 2011 aerial clearly shows the area.

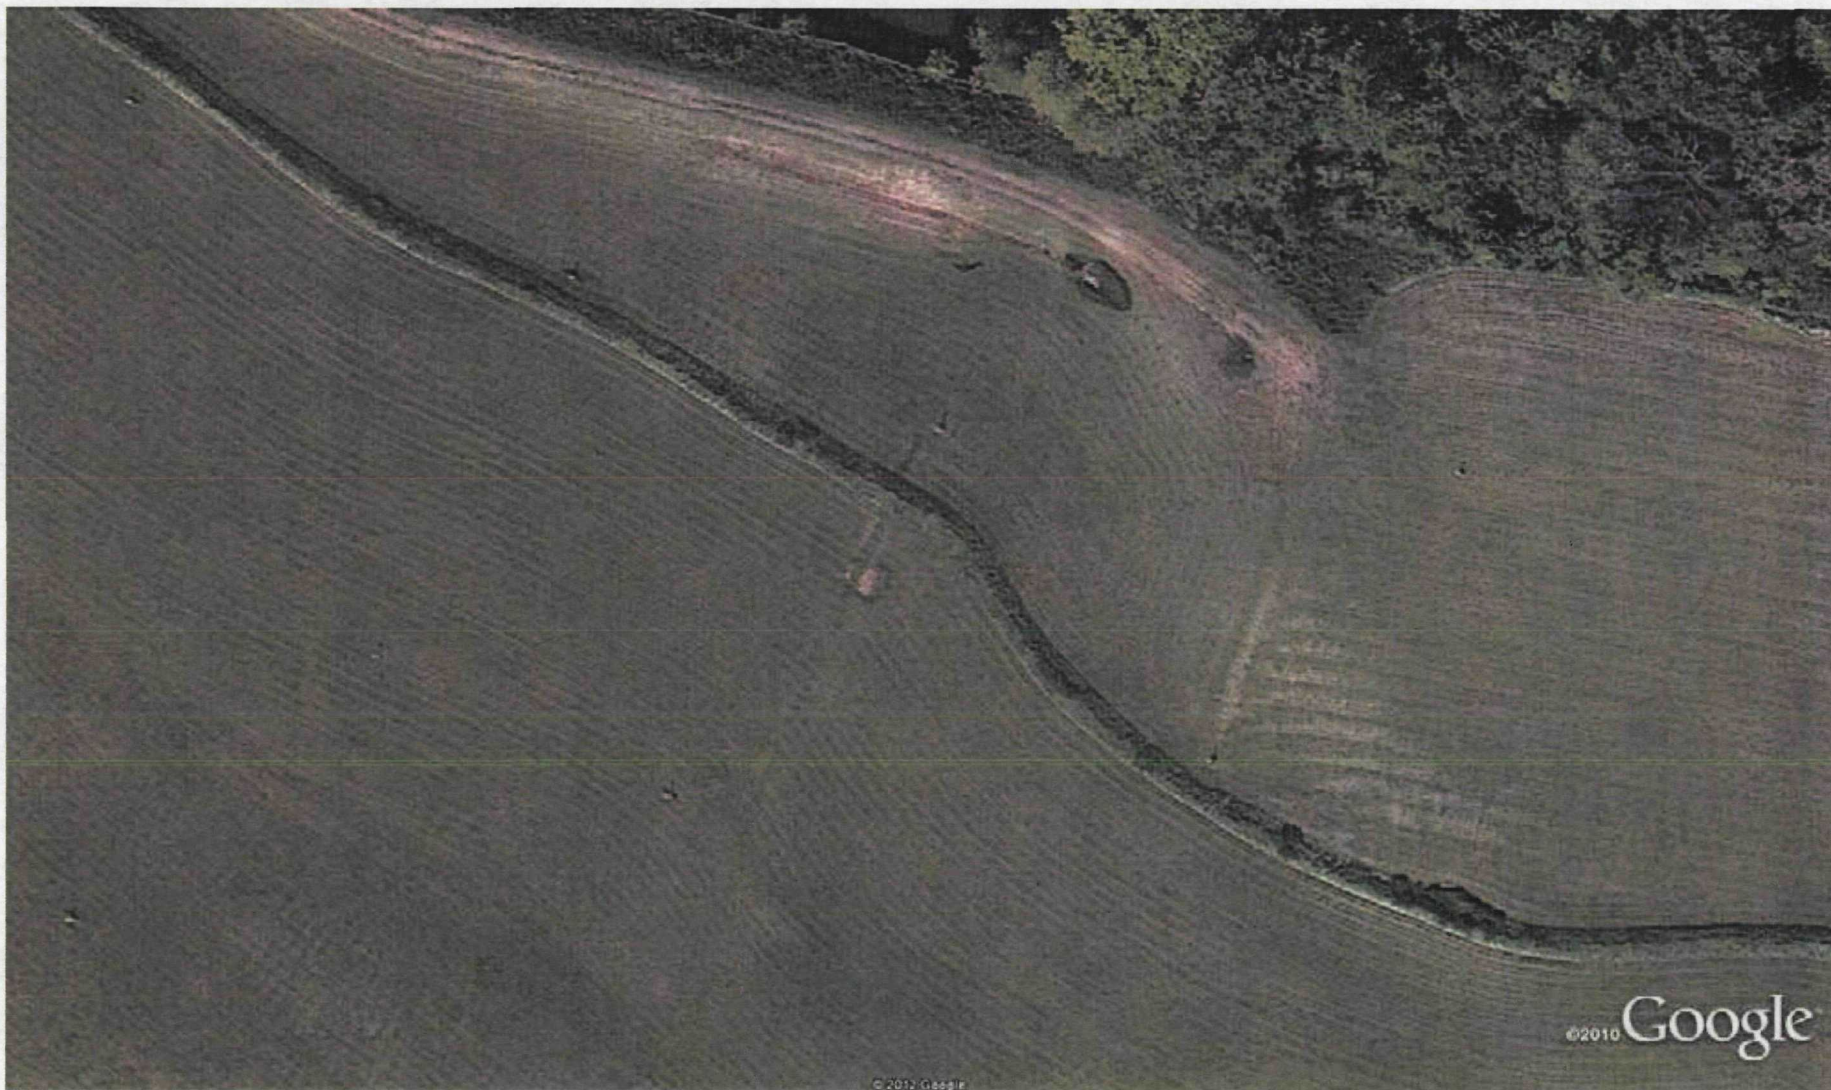
10/4/2011
Google Earth

The KHL OU-3 spot that now has dead vegetation and some subsiding is just south of the berm, and is shown best on the last attached slide (#4). I think this has happened in the past year. Again, I do think it is worth looking at by a landfill engineer and propose you provide such a person with landfill experience, and I want to bring one of our landfill people. There is also an extremely large area of "iron bacteria" in the area of the north pore water discharge ...not saying they are related, but both items should be inspected. Can we set up an on-site meeting to get this looked at, when there is no snow cover? Before the meeting, I recommend a review of subsurface structures present within the landfill to consider possible reasons for the dead vegetation and subsiding, and having whatever schematics you have on hand for review, if needed. There appears to be a linear component of some sort running north-south through the area of dead vegetation that may or may not be related.
